## CANTERBURY MUSEUM BUILDING CONSERVATION PLAN

Adopted by the Canterbury Museum Trust Board  
14 October 2019

## DPA ARCHITECTS

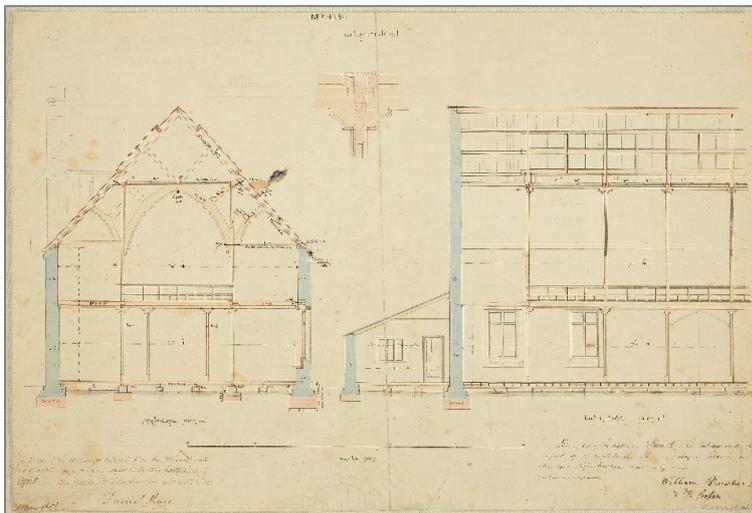
B W Mountfort’s sectional drawings for the first museum building, April 1869.  
B W Mountfort architectural plan, Canterbury Museum Plan 655.

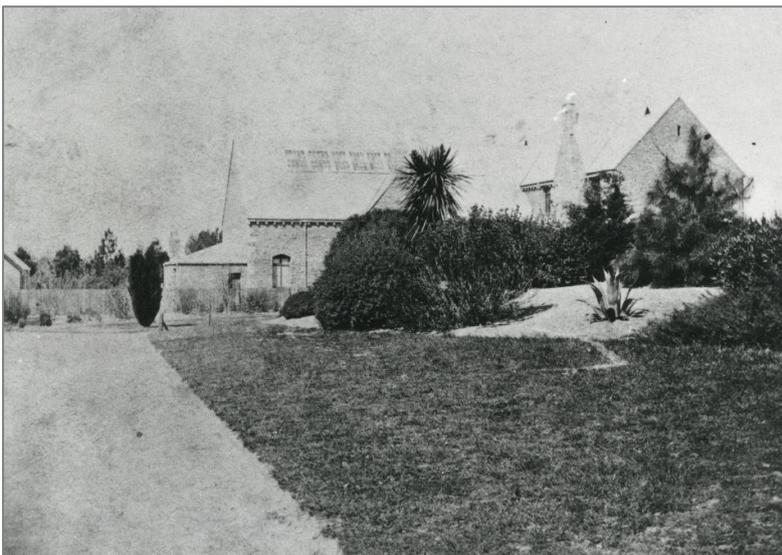
1870 building with the lean-to to the left and the 1872 building to the right  
The expanded Museum viewed from the Botanic Gardens c1874.  
Canterbury Museum Neg 6626

The Museum had no sooner opened than the Director was complaining about a lack of space for the collections and plans were made for additions.<sup>29</sup> Tenders were called in October 1871 and a new building was constructed adjoining the south wall of the 1870 structure, extending to the west so that the two parts together formed an L shaped plan. The Museum was closed for a period of one month in July/August 1872 while the alterations were being carried out.

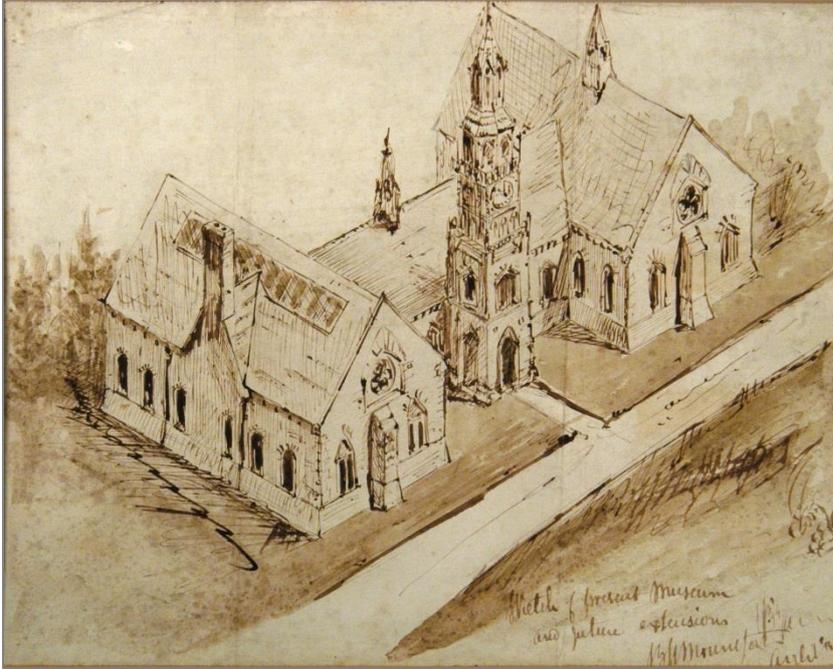
Mountfort's sketch of present Museum and future extensions, c1865 with the original 1870 building on the left  
B W Mountfort ink and sepia washed sketch, Canterbury Museum 1951.169.2.

Further additions were planned in 1873 and in the following year, Haast sent a memo to the Government with sketches showing proposed major extensions to the Museum.

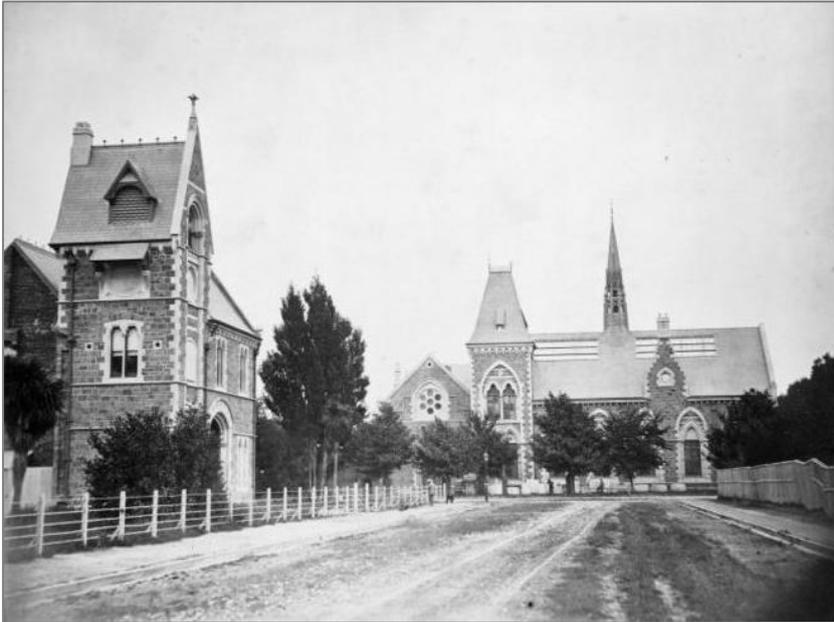
Canterbury Museum front (east) facade 1877 showing the chimney of the east facade with Canterbury College (now the Arts Centre) on the left. PA1-f-032-18. Alexander Turnbull Library 554425-1/2

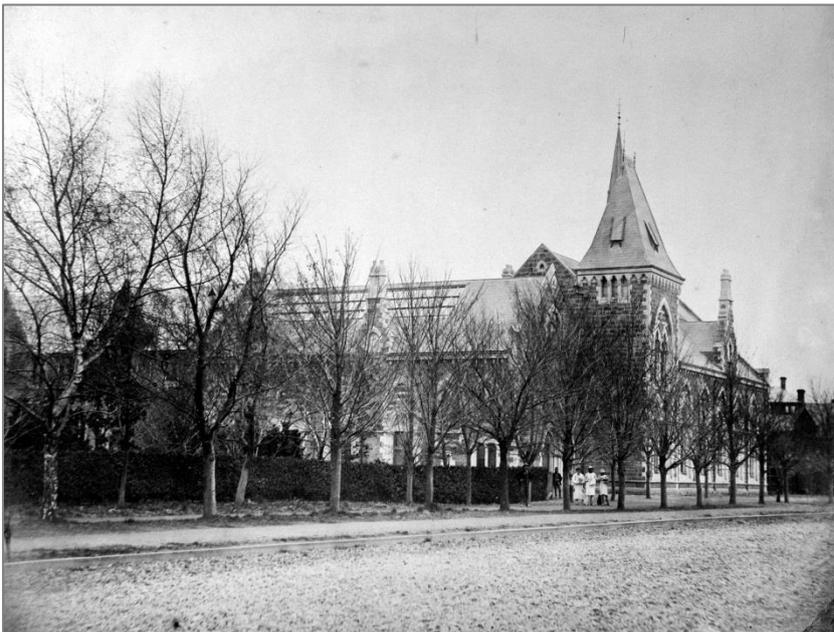
Canterbury Museum, 1877 as seen looking north along Rolleston Avenue. Chimneys are visible on the east and south elevations. Canterbury Museum, c1870, Wynn Williams album, Canterbury Museum, 1982.199.5

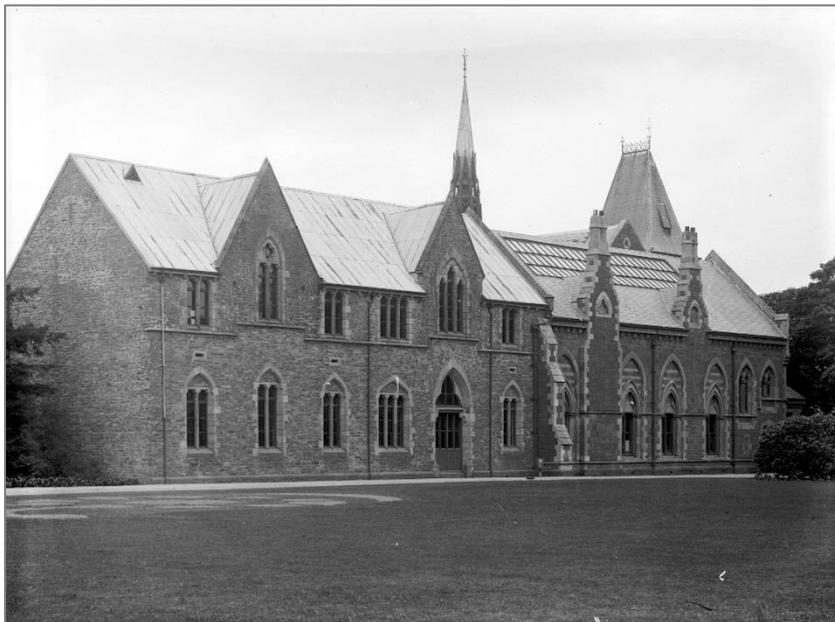
Canterbury Museum from Botanic Gardens showing 1872 and 1877 wings, showing the two chimneys on the south facade and fleche  
 W A Taylor photograph, W A Taylor Collection, Canterbury Museum 1968.213.633

The wing along the street had an interior similar to the 1870 building: a single top-lit space with a gallery around the four walls at an upper level. These extensions, completed in 1877, brought the entrance to its current location, more directly off the street, while Mountfort's signature geometric rose window featured in the gable above the entrance.<sup>32</sup>

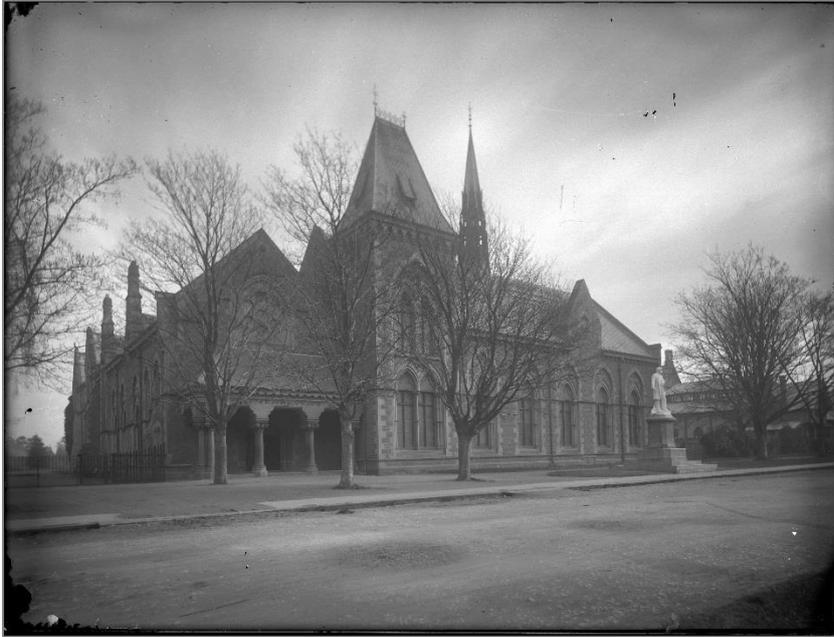
Canterbury Museum as completed in 1878, showing the south facade with the porch in place on the east facade. Charles Beken photograph c1905, Charles Beken collection, Canterbury Museum 1955.81.677

The entry portico with its decorative stonework was added in 1878 and clearly defines the entry to the Museum.

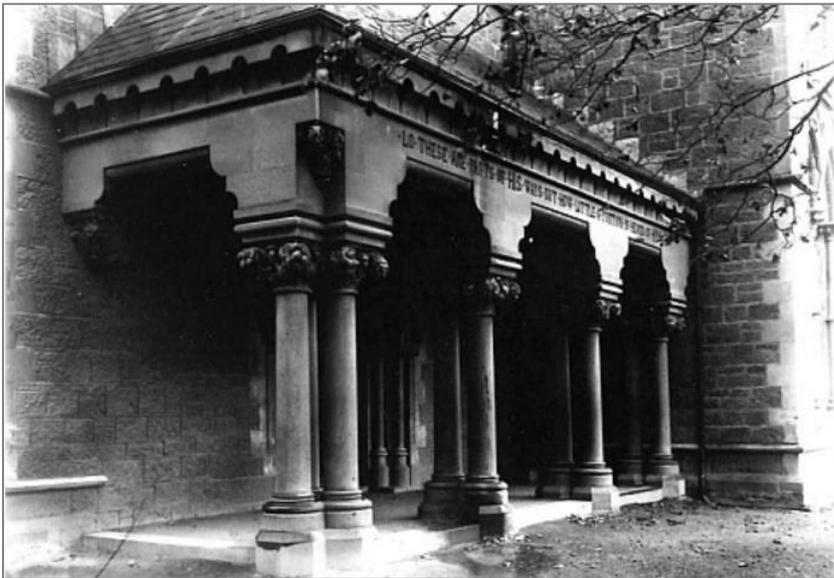
Hoon Hay Basalt columns of the 1878 porch  
MB 1051, Charles Chilton photographs, reference code 16725, photograph by Charles Chilton  
Macmillan Brown Library, University of Canterbury –  
<https://blogs.canterbury.ac.nz/librarynews/category/imageoftheweek/page/5/>

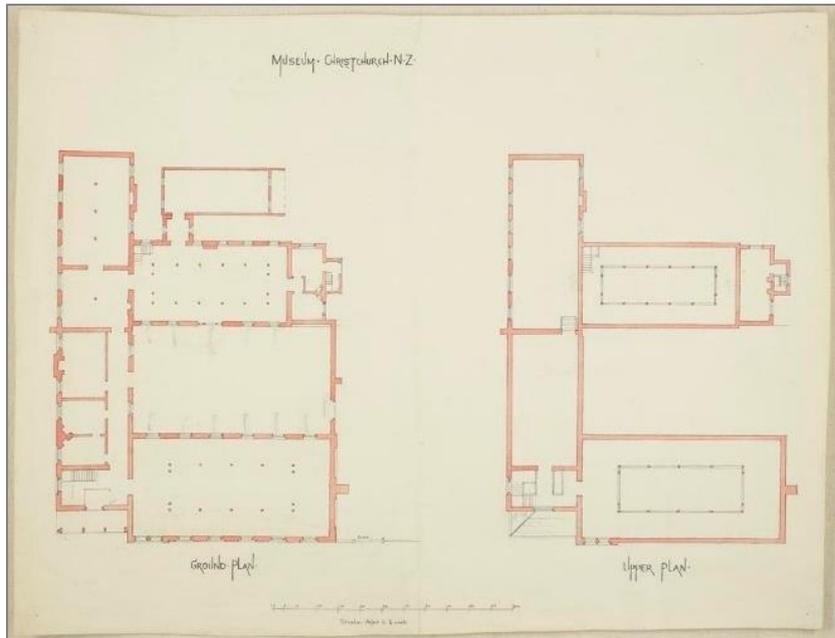
BW Mountfort 1881 plan showing the completed buildings. The floor and upper plan of the Canterbury Museum  
B W Mountfort architectural plan, Canterbury Museum Plan 661

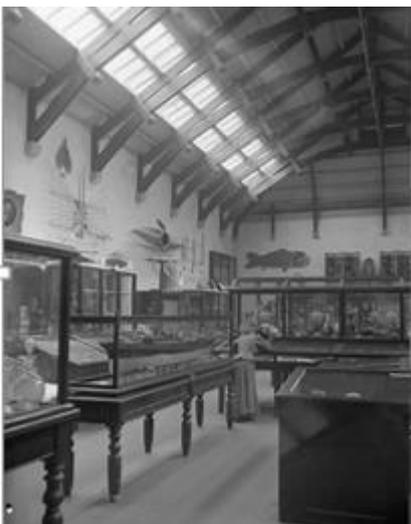
Canterbury Museum interior of the 1882 building. Photograph by A W Reid  
Puke Ariki PHO2012-0452: <https://collection.pukeariki.com/objects/166900>

The 1882 addition opened as a technology gallery – although photographs of the time also show ethnological material on display.<sup>34</sup>

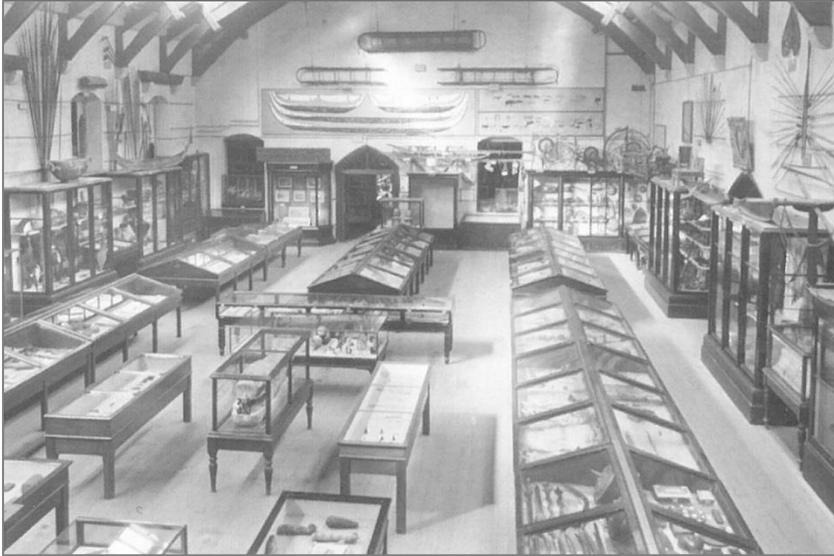
Canterbury Museum 1882 building, with glazed displays, Ethnology Room  
*Christchurch Heritage*, Auckland, Random House: 2011, 53

The 1882 building was a major engineering feat. The roof spanned 48 feet (14.6 metres) and was one of the “most impressive interior spaces built in nineteenth-century New Zealand”.<sup>35</sup> The museum remains today as a tribute to the extraordinary energy of Haast which resulted in the construction of four separate but connected buildings, all of which were completed within a period of 12 years. By comparison, Christ Church Cathedral was not completed until 1904, some 40 years after construction began.

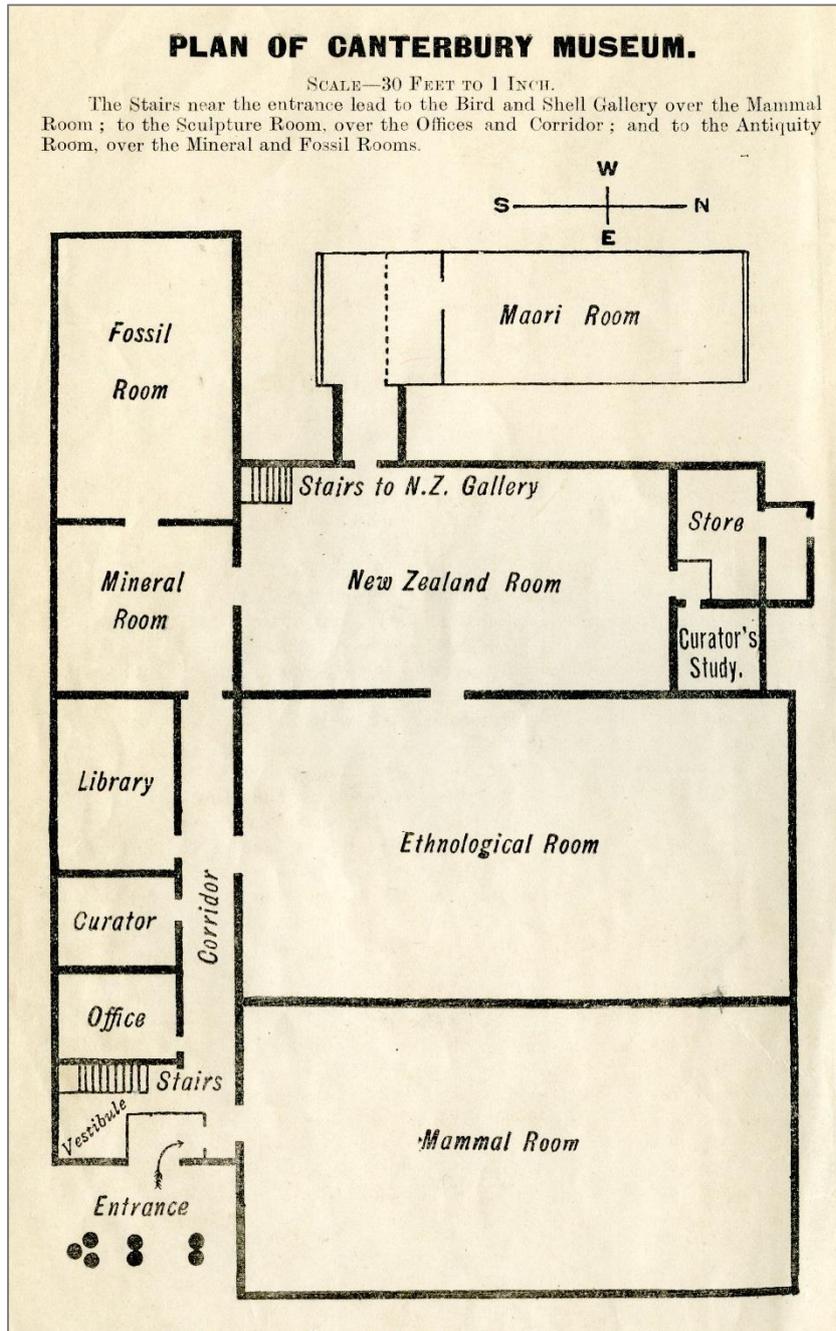
Plan of Canterbury Museum from 1900 showing the whare location and the vestibule next to the entrance. Canterbury Museum, LIB5991.

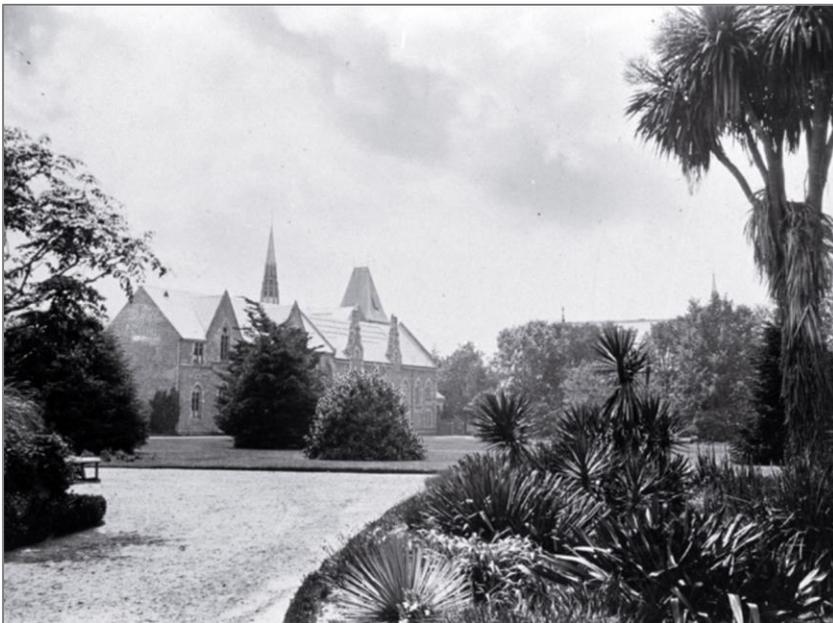
View back from the botanical gardens showing the fleche and the 1872 and 1877 buildings c1900  
Archive 334, 90, Photo CD 3, IMG0037

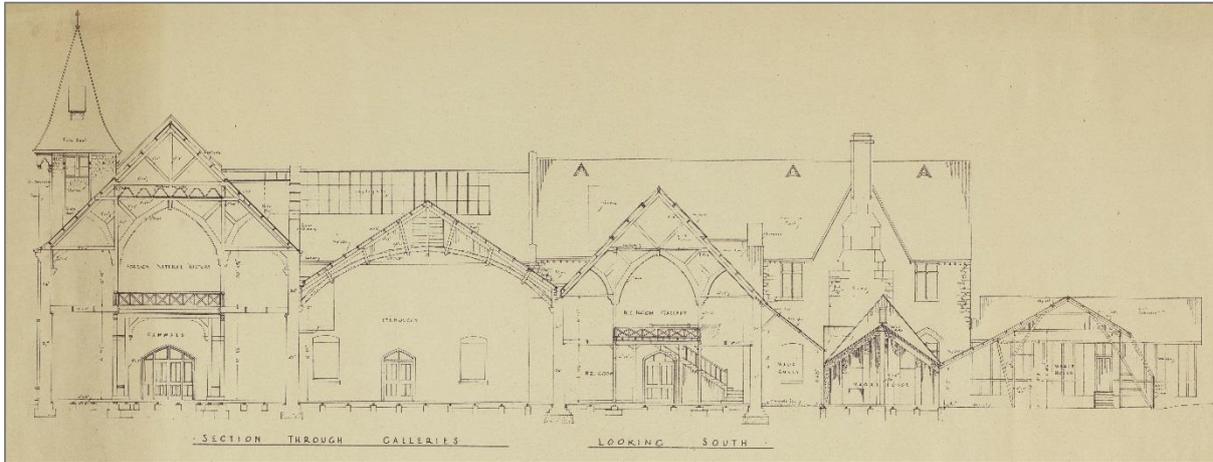
Section through Canterbury Museum from Rolleston Avenue – October 1948. From left to right: 1877 East wing, 1882 wing, 1870 wing, 1872 building behind where in foreground and structure to the far right may be the shelter for the blue whale. Sheet No 4, 08 October 1948, J G Collins architectural plan, Canterbury Museum Mu 5.

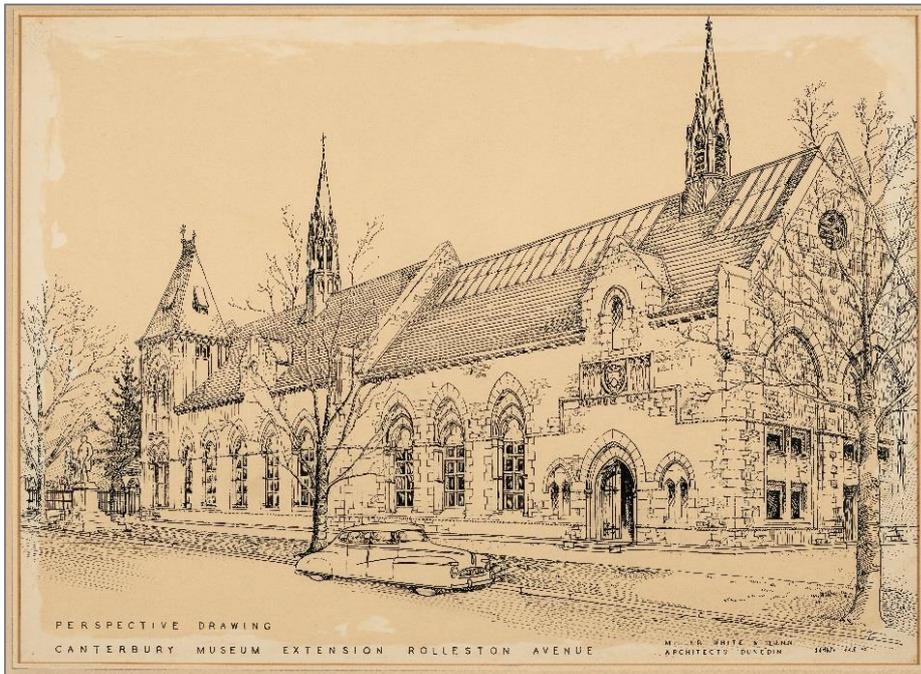
The stone detailing to the north facade was never realised  
 Perspective Drawing Canterbury Museum Extension Rolleston Avenue 1949  
 Miller, White and Dunn drawing, Canterbury Museum Mu 30a.

The building that was finally constructed only had two Mountfort styled windows in the east elevation, the fleche was omitted from the roof and most significantly, the Gothic detailing was absent from the north elevation which became a utilitarian plastered concrete box. The elimination of the Gothic detailing from the north elevation destroyed any illusion that the building might be authentic and that the stonework on the face was anything more than a skin-deep veneer. The missing window on the east elevation and the inconsistent scales of the other windows and the single height doors with the smaller windows to either side results in an awkward juxtaposition of elements.

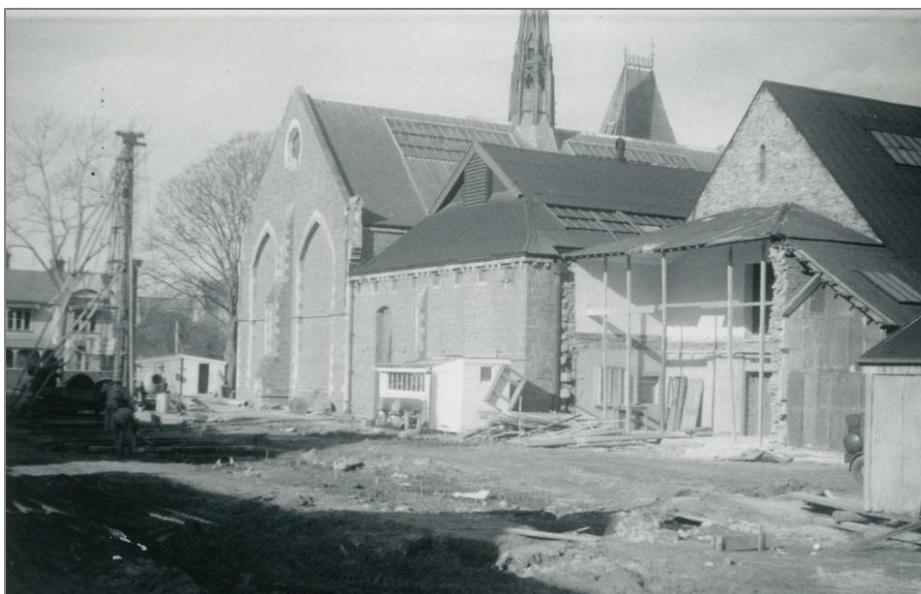
Image from 1955 prior to the Centennial Building works showing the north ends of the 1877, 1882 and 1870 wings. The lean-to on the 1870 wing has had an additional storey added.  
 Canterbury Museum 1955, Canterbury Museum

These included the replacement of the gallery in the upper level of the 1877 Rolleston wing with a full floor, creating a space for a new bird gallery to be installed beneath a barrel-vaulted ceiling. In 1957, as part of the work, the fleche or spirelet which had deteriorated into a state of decay was removed from

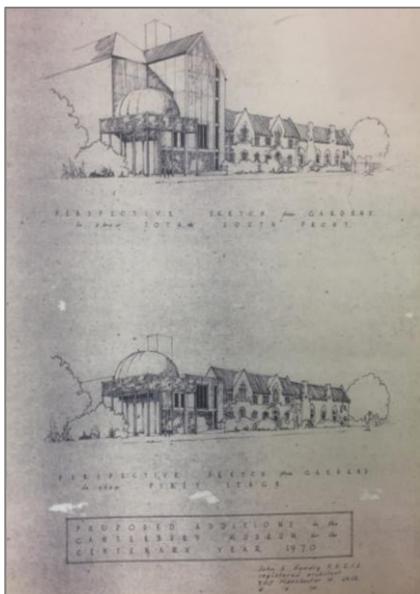
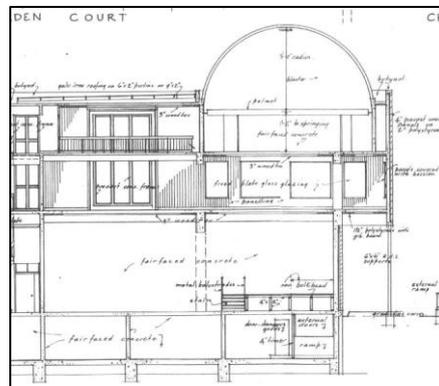
Part of a working drawing showing the cross section of the Duff Wing with Planetarium

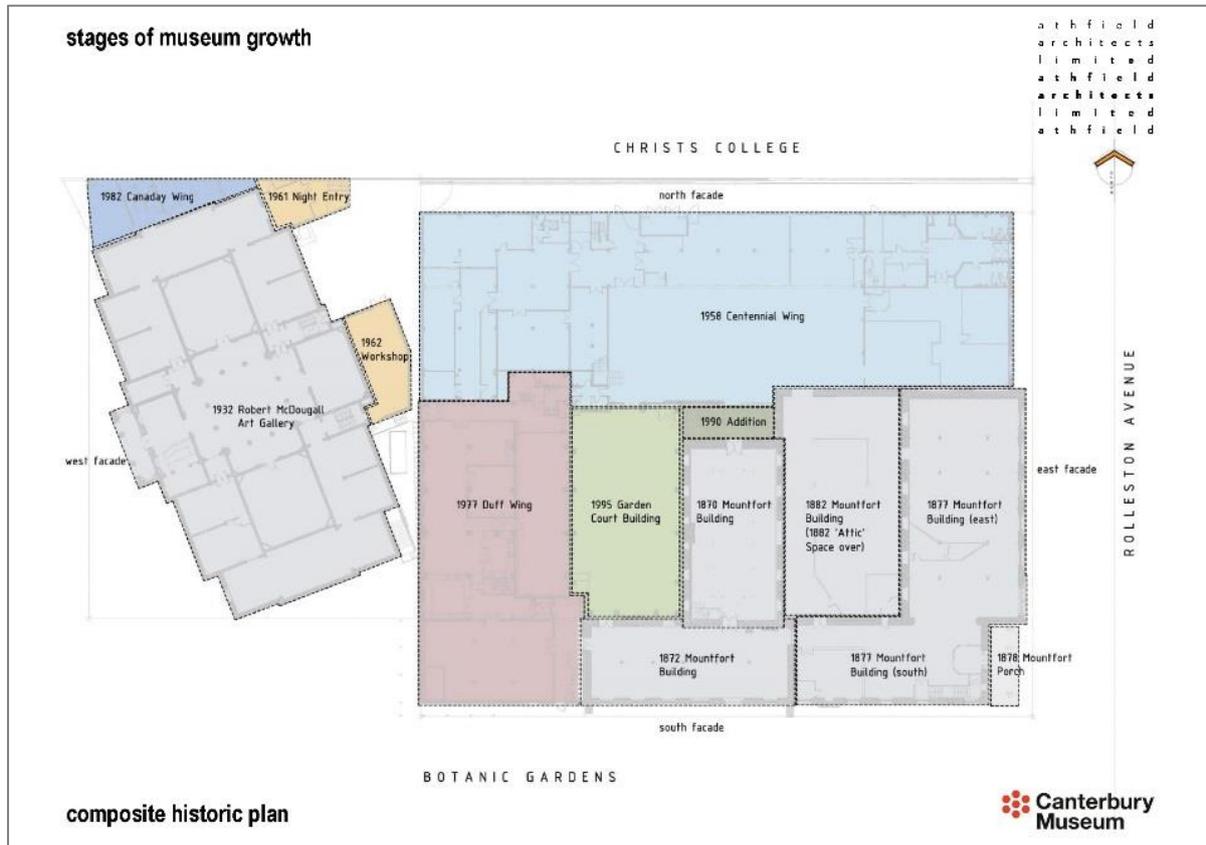
Stages of buildings that make up Canterbury Museum. Plan from Athfield Architects

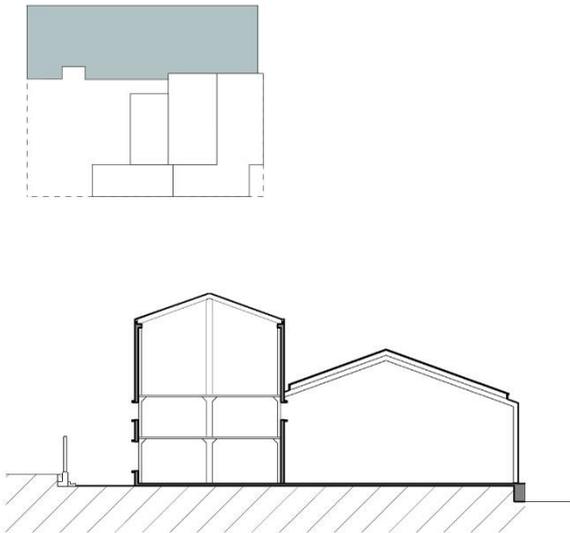
**Centennial Wing, 1958**

This wing is constructed out of reinforced concrete slabs and columns and walls, with concrete foundations. Steel joinery has been used with the exception of the Rolleston Avenue façade, which contains timber joinery.

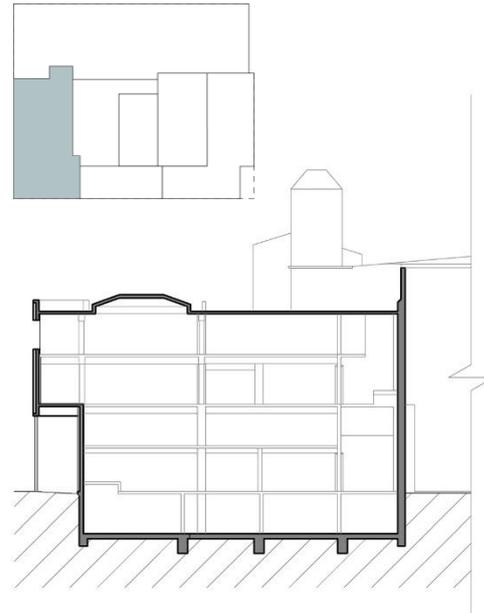
**Roger Duff Wing, 1977**

Concrete was again used for the construction of this wing. A system of concrete slabs and columns, with concrete foundations has been used. Externally the building features bare concrete and pre-cast concrete panels with exposed basalt aggregate. Steel joinery was used in the original construction, however, when the changes were made in 1990s, aluminium joinery was used for the new openings. The wing features a flat, membrane roof.

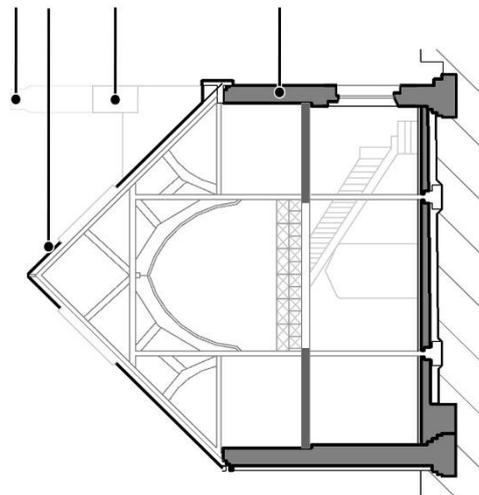
Original chimney height (dotted)

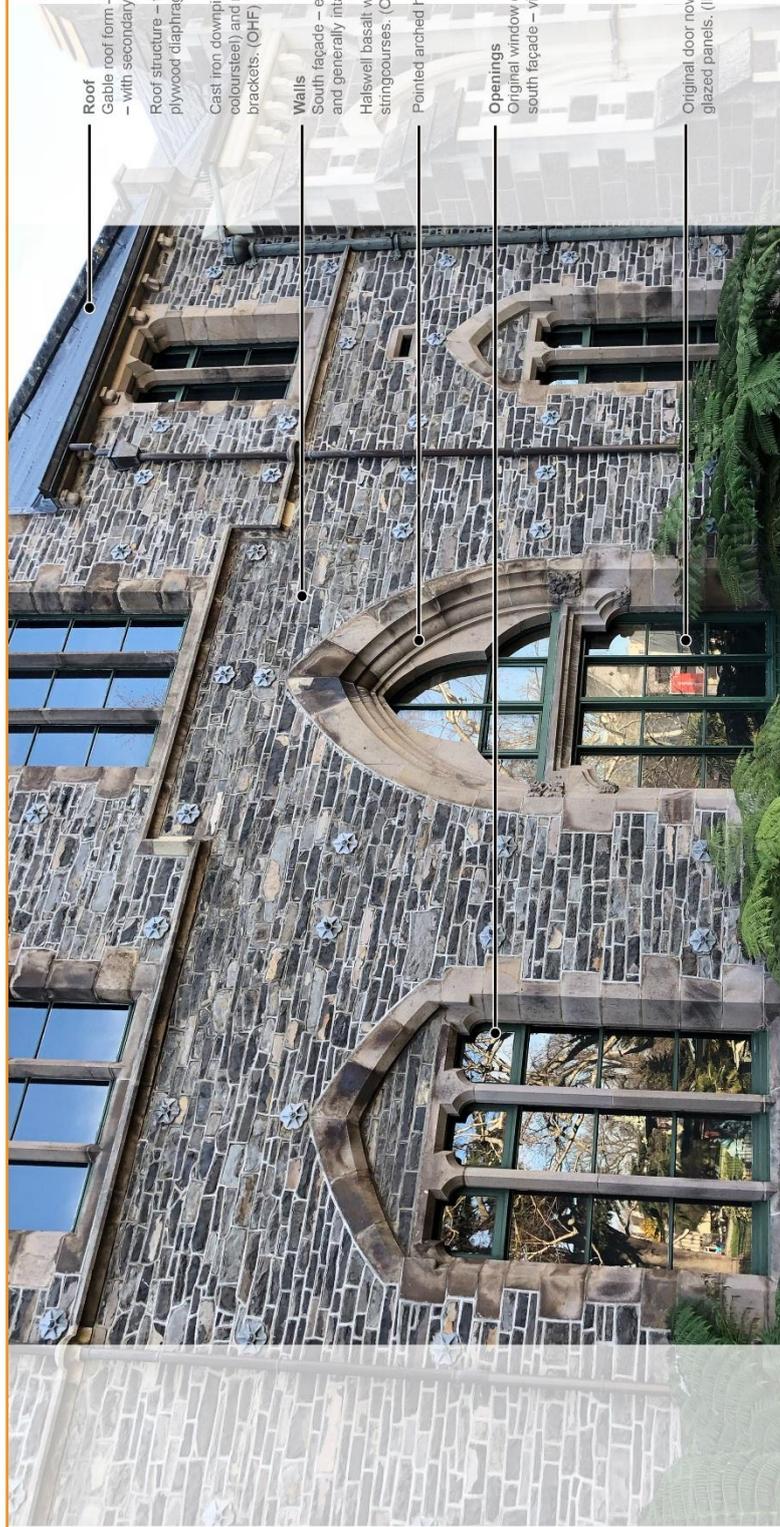
**Roof**

Gable roof form - approximate pitch of 45 degrees - with secondary gables. (OHF)

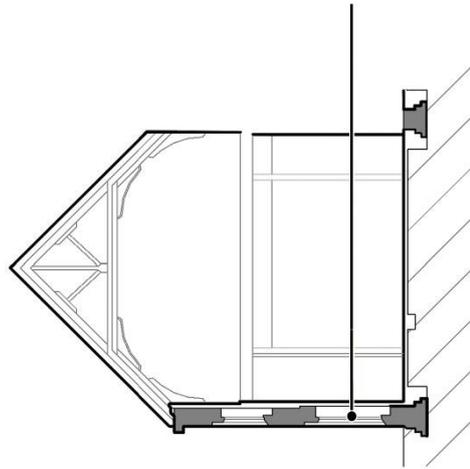
**Upper Floor:** Original trusses within roof space (OHF) image 3. Exposed knee brackets, supported on timber pilasters partially concealed by exhibition set up - could be further exposed. (OHF)

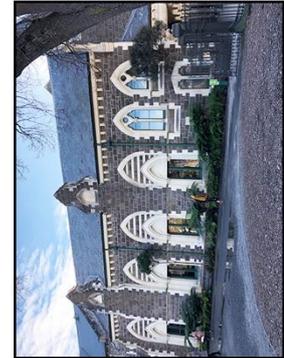
**Entrance Porch:**

Rose window above entrance porch. (OHF)

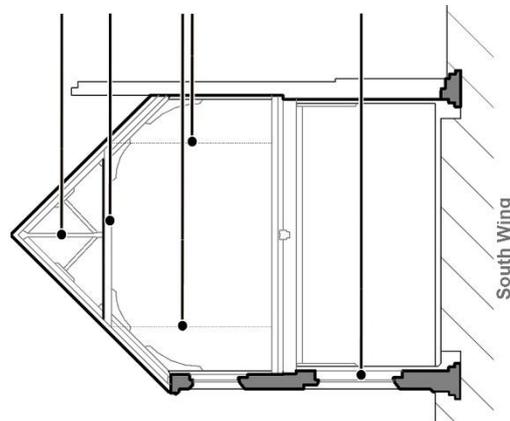
Trusses within roof space (OHF) image 4.

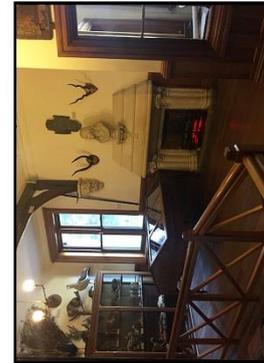
(3)

Original beams and corbels. (OHF)

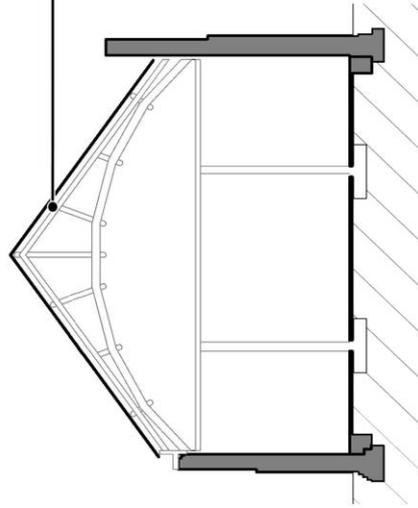
Significant heritage fabric inside this space - the large spanning, "double" trusses. (OHF) Images 2 and 3.

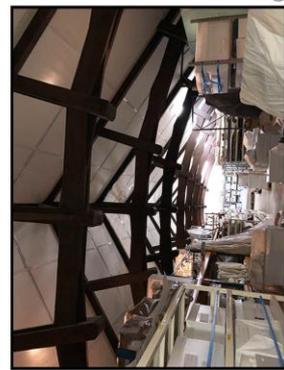
Original timber "double" trusses in space used for mammal storage. (OHF) (2)

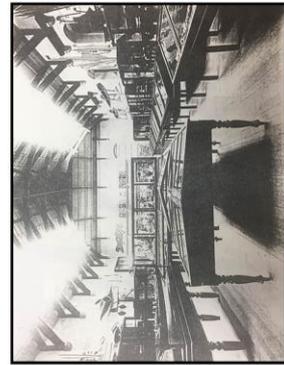
Historical photo showing the timber "double" trusses. (OHF) (3)

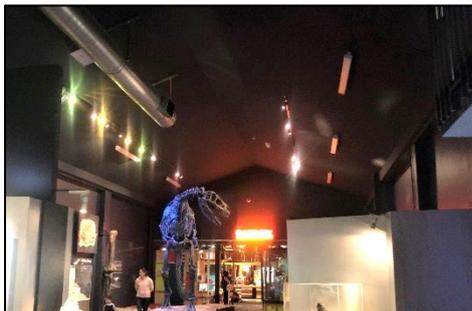
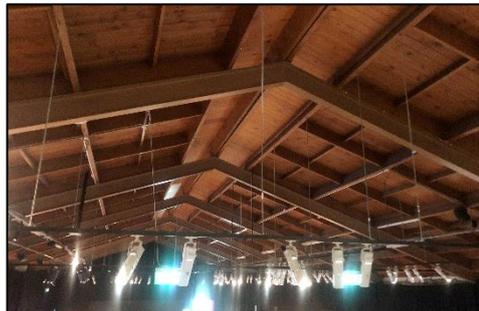
Interior of Centennial Wing

The interior of the Centennial Wing is a utilitarian structure which contains a large space designed to display exhibits. The western section of the wing contains offices for museum staff. The interior of the Centennial Wing is considered to have little or no significance.

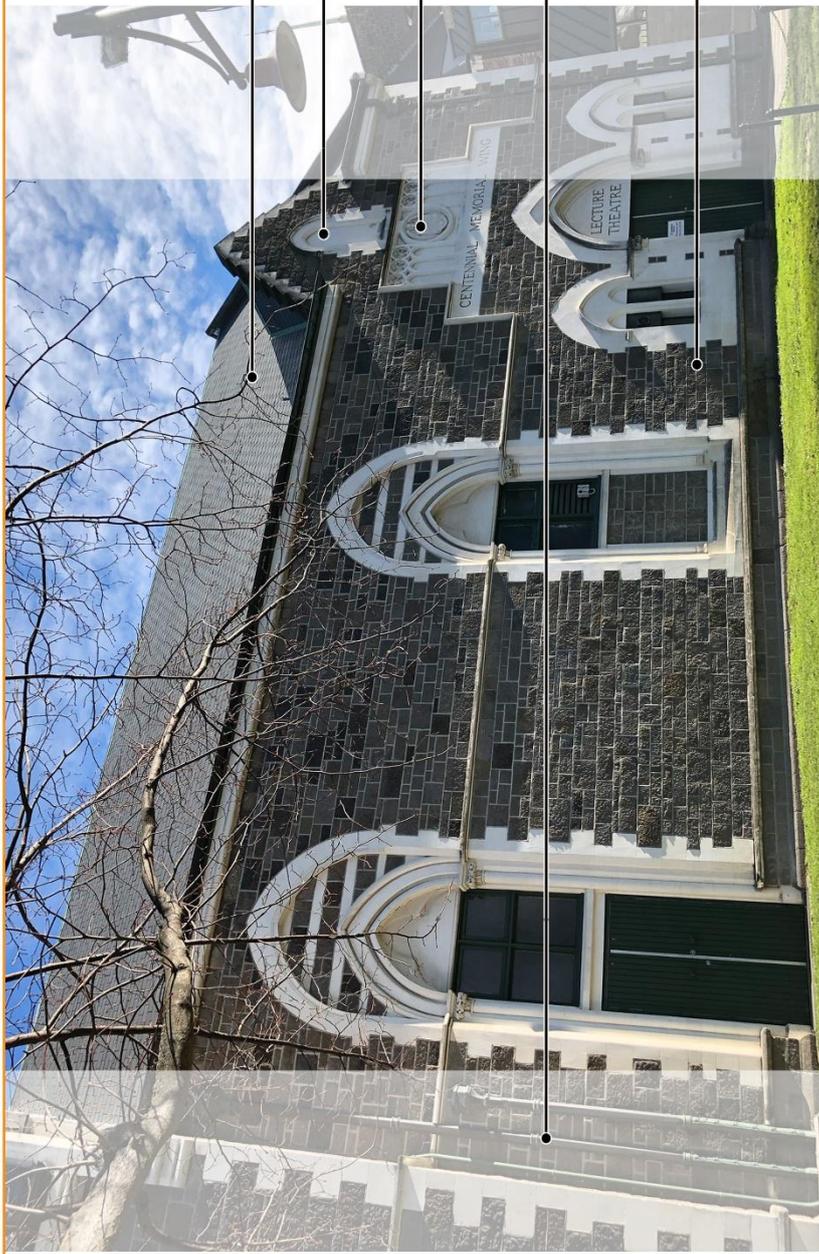
- Walls**  
This building has concrete walls with a plastered finish on the north and west elevations.  
The east or Rolleston Avenue facade is clad with a veneer of basalt to match the 1877 building. It includes Port Hills basalt over concrete in random squared coursed rubble with dressed Oamaru stone facings, stringcourses, modillions, mouldings, quoins and mullions.
- Slate on steel frame (LHF)
- Gablet or blind opening. (LHF)
- Canterbury Coat of Arms. (LHF)  
The coat of arms displayed is a version of the coat of arms of the Canterbury Provincial Government founded in 1873. A similar coat of arms can be seen on the Clocktower of the Arts Centre, previously Canterbury College.
- 2 x downpipes (LHF)
- Oamaru stone facings. (OHF)

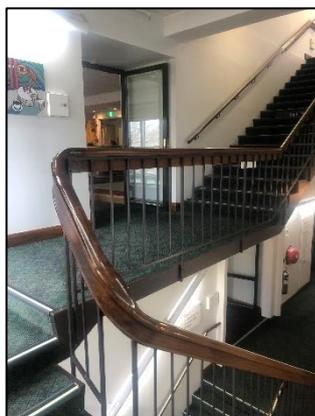
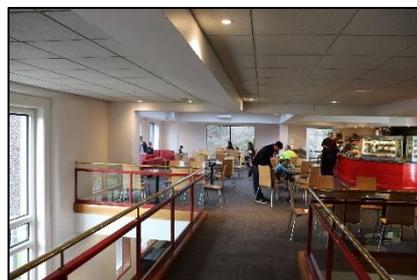
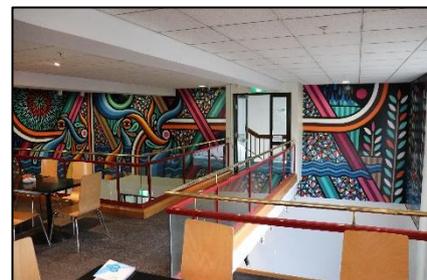
The interior of the Duff Wing comprises largely functional spaces that have been extensively modified following the removal of the planetarium and the establishment of the cafeteria. The staircase and the bridge, along with the remainder of the interior, are considered to have little or no significance.

Interior of Duff Wing. Staircase (left) and cafeteria (right).

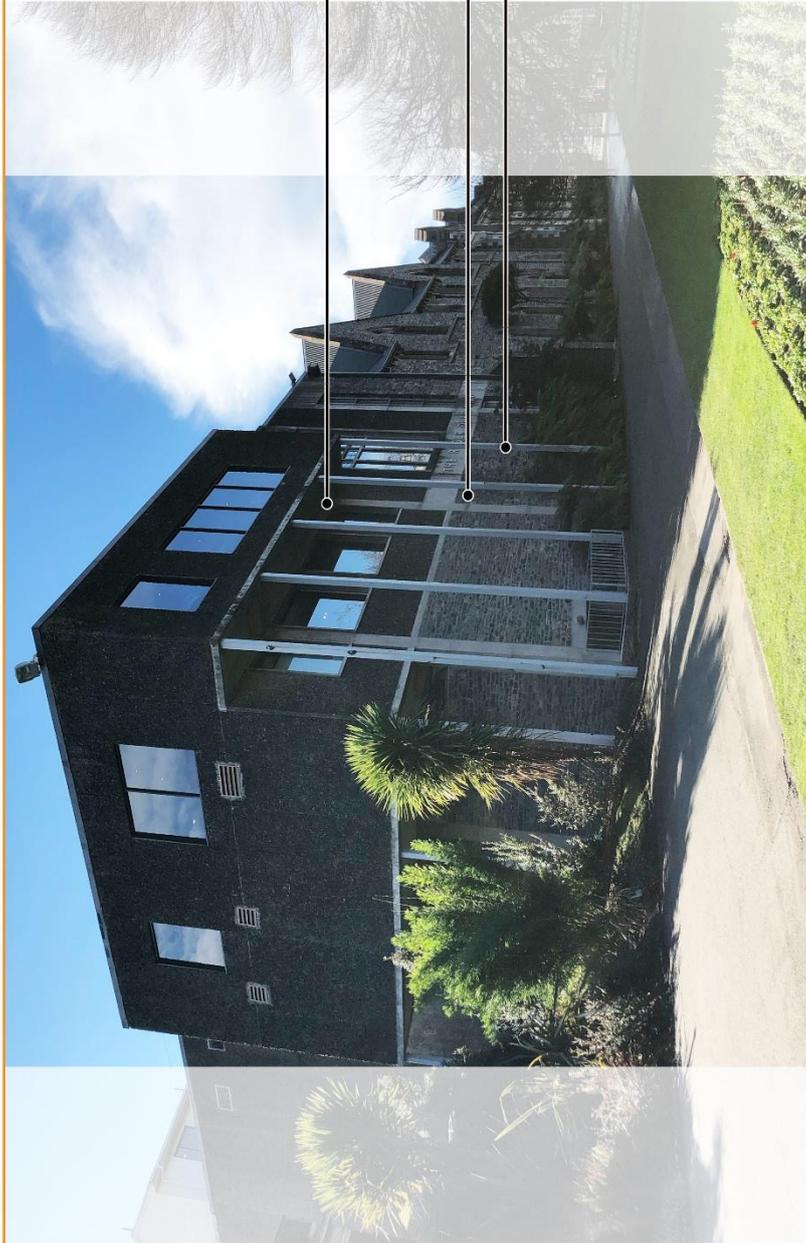
This building features walls, which are a combination of raw concrete and pre-cast panels with exposed, basalt aggregate. However, some of these are not intact due to the openings which have been formed for the café windows. (LHF)

This Halswell Basalt Veneer. (LHF)

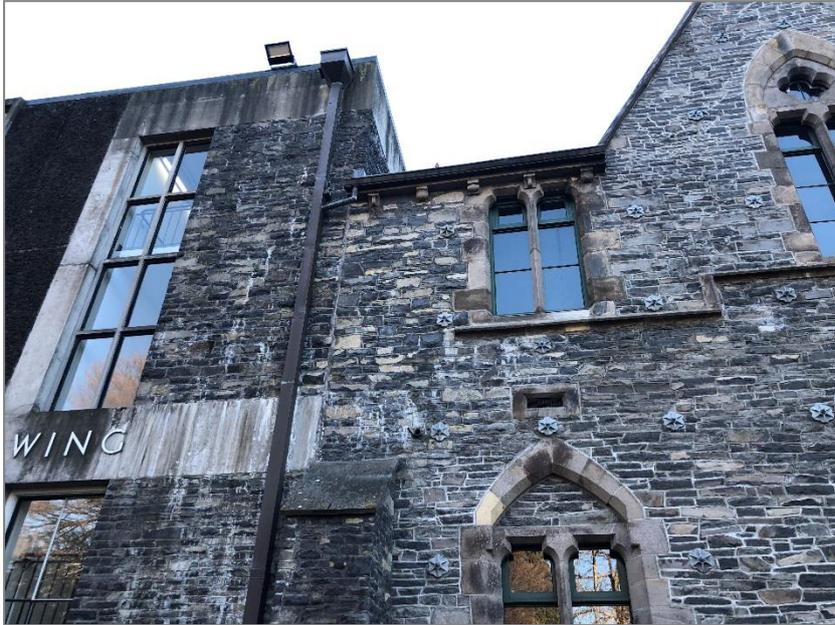
The existing junction between the Roger Duff Wing and the 1872 Mountfort building is unresolved and does not provide adequate seismic or appropriate visual separation. Improved seismic separation is likely to be required in this location and should be designed to only impact on the later Duff Wing. (2018, DPA Architects).
